S-294
Berry House
Tulls Corner vicinity
private

Maryland Historical Trust State Historic Sites Inventory Form

Survey No. S-294
Magi No. 2002945704
DOE ☐ yes ☐ no

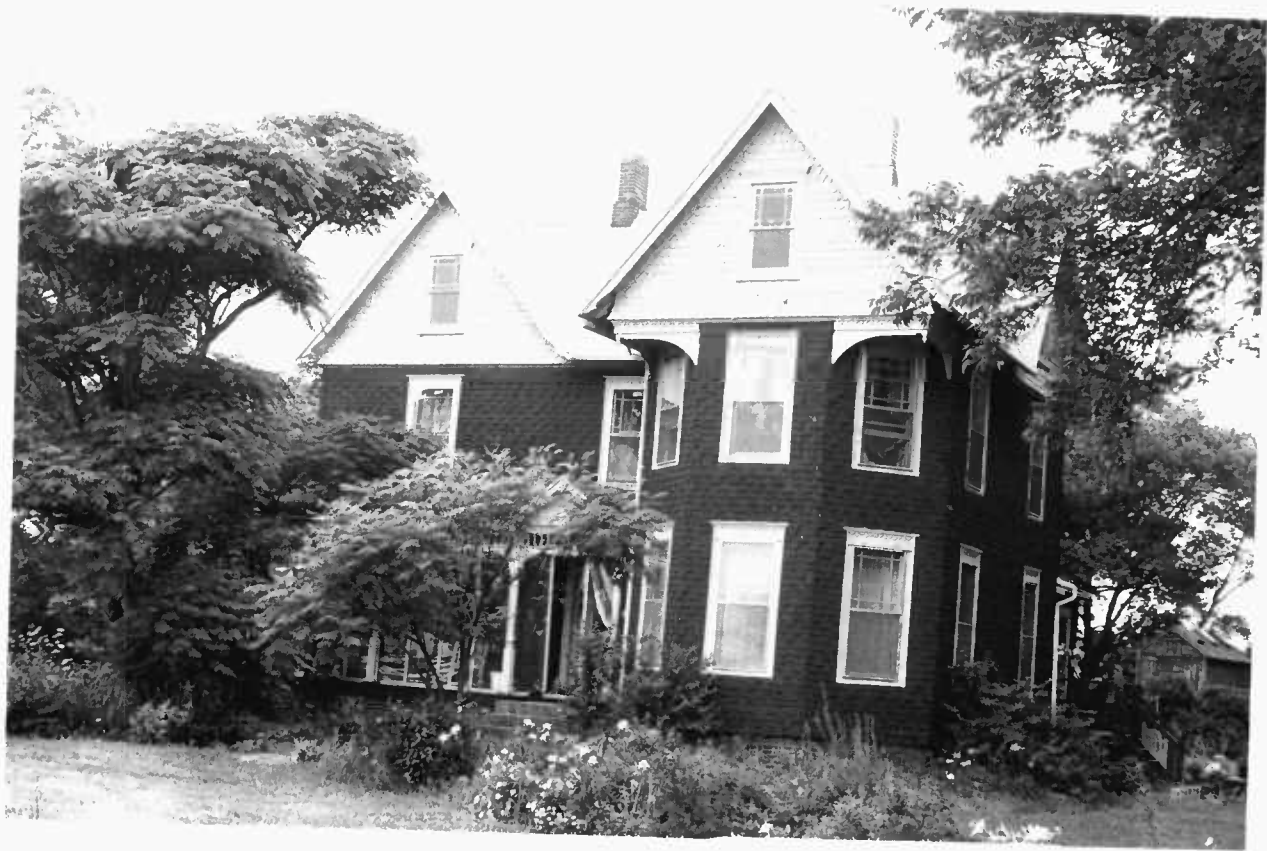
The south facade is an uneven elevation with a projecting two-story east bay window, and a centrally located front door. A turned post porch with spindles and corner brackets highlight the porch along with a small gable-front that is covered with fishscale shingles. The two-story five-sided bay is pierced on each face by multi-pane sash windows treated with a decorative edge along the window lintel. The lower corners of the gable-front roof are trimmed with corner brackets. The upper gable is covered with patterned fishscale shingles and pierced by a multi-pane sash window. The eaves are extended, and the decorated rafter feet are exposed.

The recessed entrance wall has a sidelighted glazed door and flanking multi-pane sash windows. Centered above the west bay is another gable-front covered with a pattern of fishscale shingles and pierced by a multi-pane attic window.

Berry House S-294
Tulls Corner vicinity, Somerset County
South Elevation
8/85, Paul Touart, Photographer
Neg./Md. Historical Trust

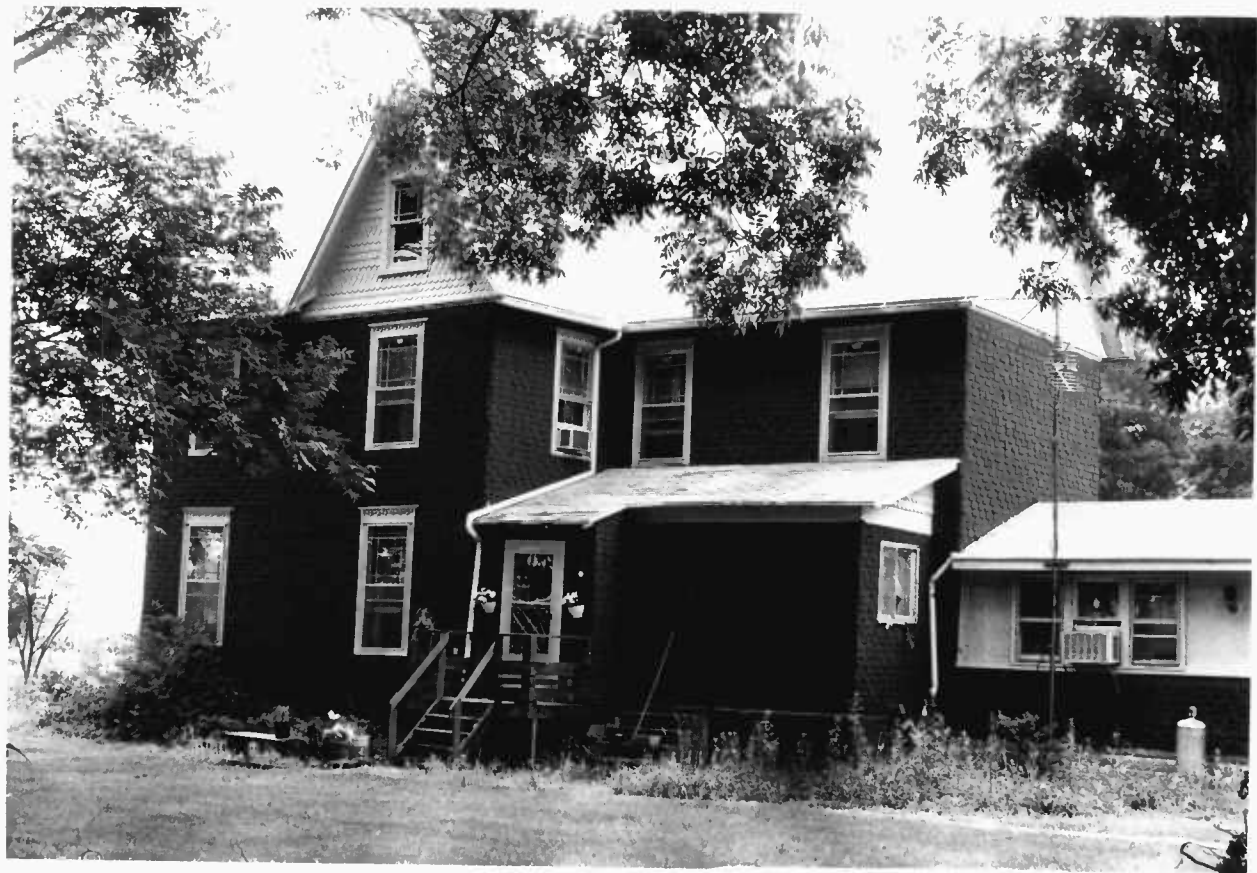
East Elevation

The east side elevation is also an uneven wall surface with two bays comprising the main house and two-bays extending to the north for the original service wing. More recently a modern single-story kitchen has been attached to the north end of the rear wing. The old service wing is recessed one bay from the surface of the main block and is filled by a single-story shed roofed addition with a side entrance porch. The remaining bays are filled with multi-pane sash windows and the gable-front is lighted by a multi-pane window as well.

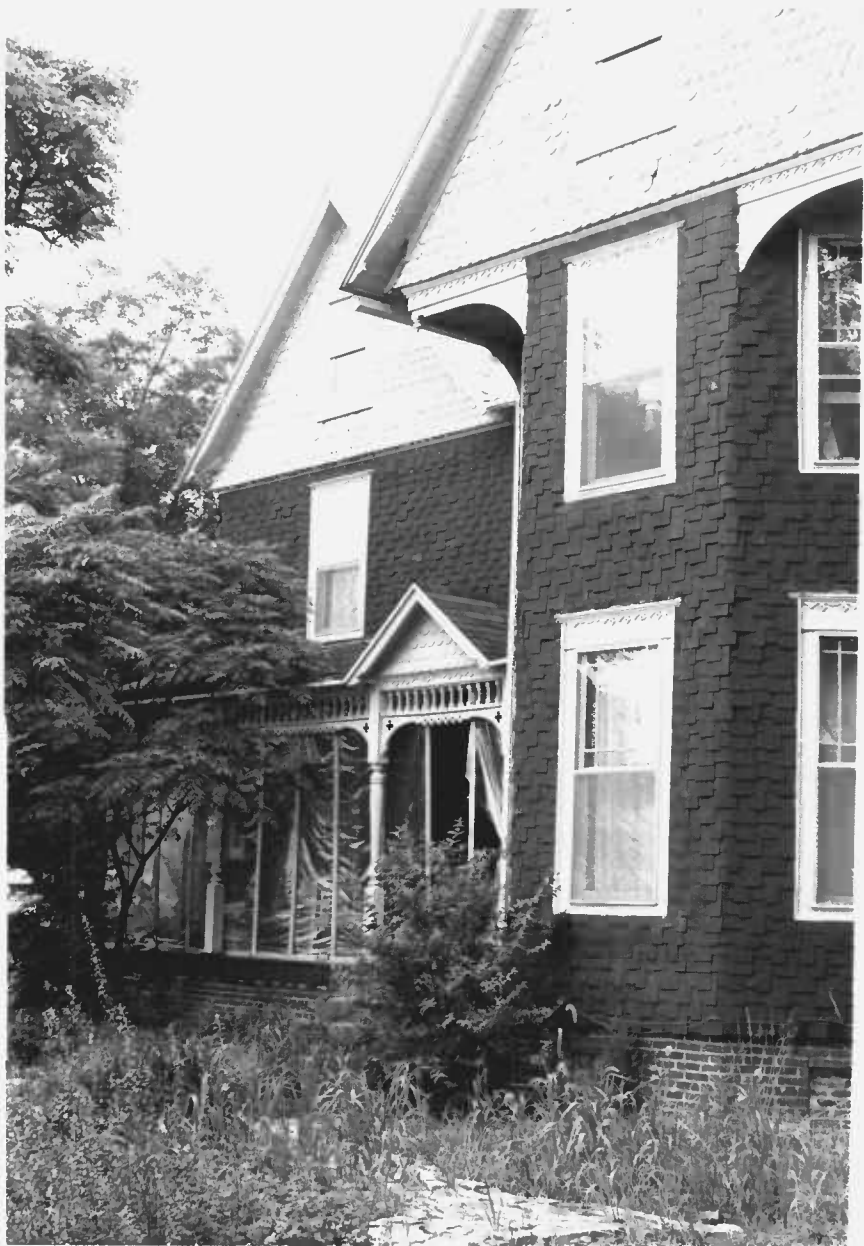
Berry House S-294
Tulls Corner vicinity, Somerset County
South elevation
8/85, Paul Touart, Photographer
Neg./Md. Historical Trust

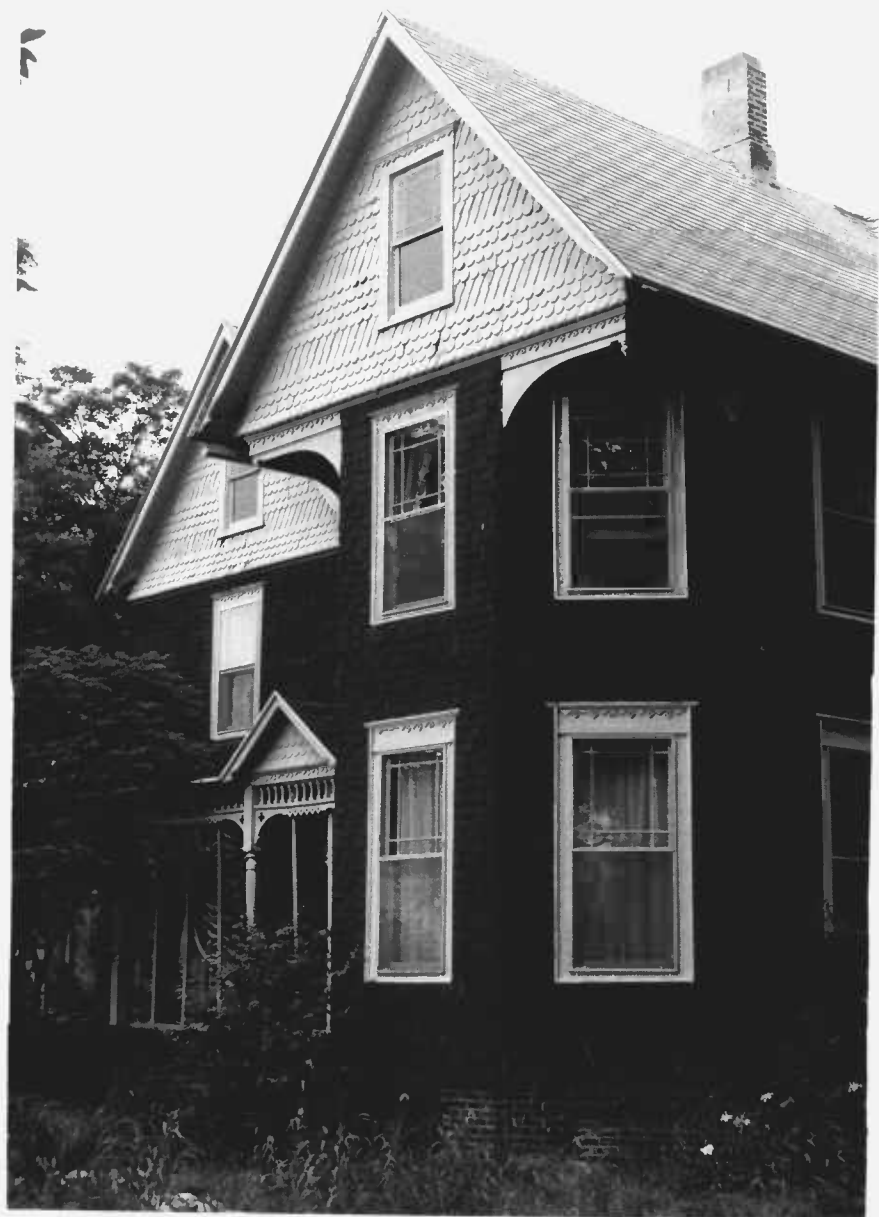
Berry House S-294
Tulls Corner vicinity, Somerset County
South Elevation
8/85, Paul Touart, Photographer
Neg./Md. Historical Trust

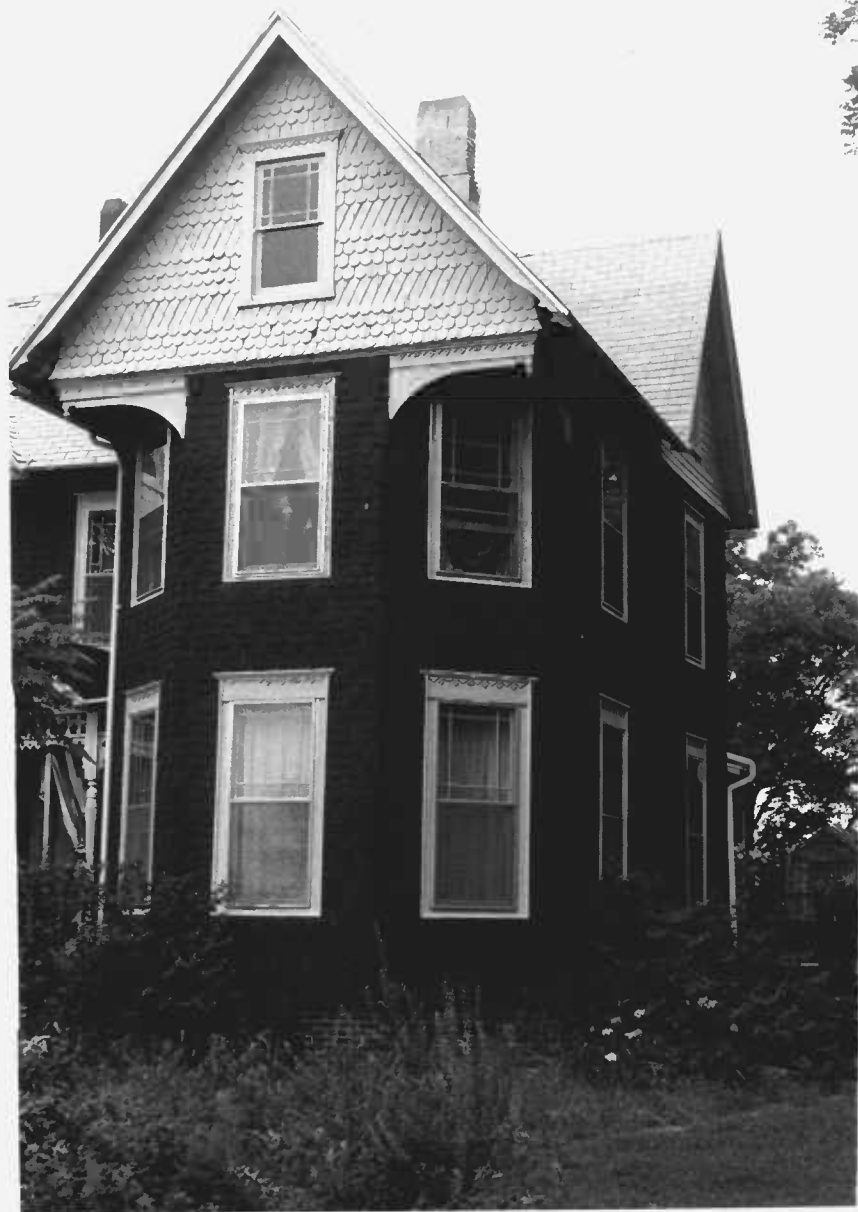
Berry House S-294
Tulls Corner vicinity, Somerset County
South Elevation
8/85, Paul Touart, Photographer
Neg./Md. Historical Trust
